**N.J. NO NAME DAM  
NO. 40**

**NJ 00208**

**PHASE 1 INSPECTION REPORT  
NATIONAL DAM SAFETY PROGRAM**

4. TITLE (and Subtitle) Phase I Inspection Report National Dam Safety Program NJ No Name Dam No. 40 NJ00208 Passaic County, New Jersey		5. TYPE OF REPORT & PERIOD COVERED  FINAL

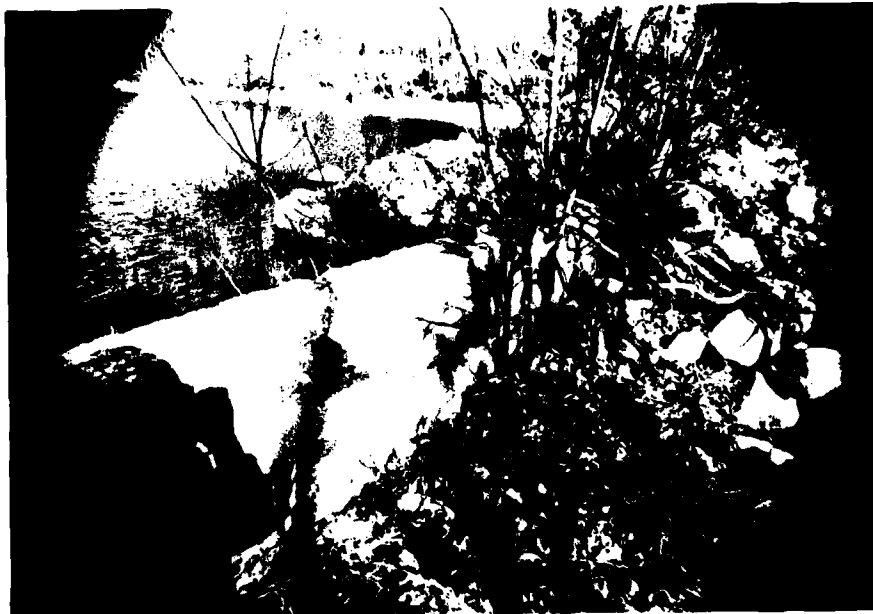
EMBANKMENT	
VISUAL EXAMINATION OF	REMARKS AND RECOMMENDATIONS
SURFACE CRACKS None noticed.	
UNUSUAL MOVEMENT OR CRACKING AT OR BEYOND THE TOE Cracking and spalling of the concrete wall were observed. The wall is on the upstream side of embankment and the cracking and spalling is just left of the former spillway.	Repair cracking and spalling.
SLOUGHING OR EROSION OF EMBANKMENT AND ABUTMENT SLOPES Erosion was observed on the downstream side of the embankment opposite the former spillway.	Refill eroded area.
VERTICAL & HORIZONTAL ALIGNMENT OF THE CREST Crest of the existing embankment has been covered over with rocks and dirt to form the dirt road. Therefore, the vertical and horizontal alignment of the original embankment could not be ascertained, but the alignment of the road is uneven.	
RIPRAP FAILURES N/A

Photo 3 - Detail of concrete wall, shown in Photo 2, depicting cracking and spalling.

3. The flow of seepage should be monitored monthly to determine its volume and whether it presents a problem to the safety of the dam.
4. Repair all cracked and spalled concrete within twelve months.

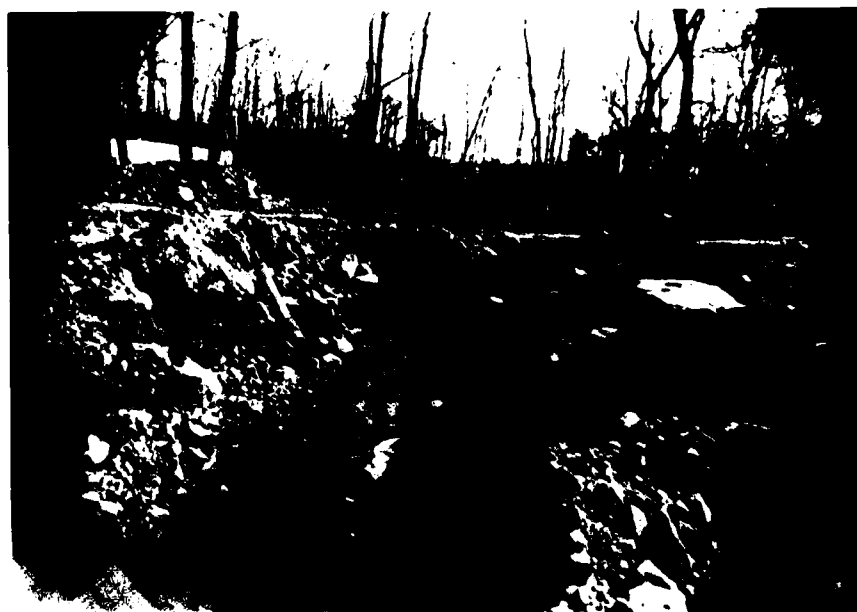
Photo 7 - View of spillway from the lake. The spillway, a 48-inch corrugated metal pipe, crosses under the embankment at its left side.

6. Provide a headwall and side slope and channel bottom protection for both the approach and discharge channels. Extend the protection for the discharge channel to beyond the embankment toe of the slope. This should be completed within twelve months, providing the pipe is not required to be replaced as a result of the hydrologic and hydraulic analysis of the dam. (Ref. Item 1).
